UNIGUARD™

New alloy addresses
formicary corrosion

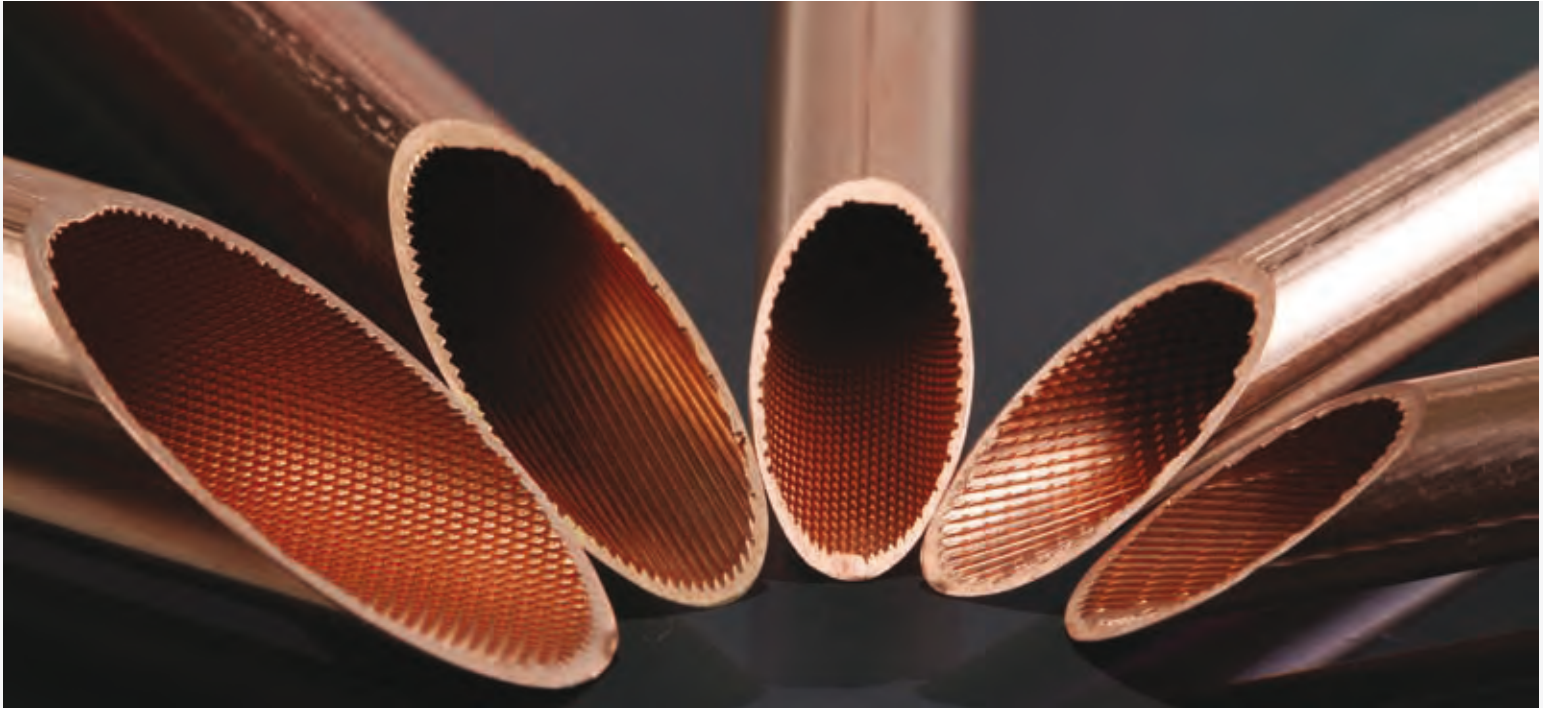
Formicary ("Ants Nest") corrosion has a unique morphology that appears as a wandering pit (see 122 alloy photomicrograph below). Pits are not observable to the un-aided eye. This type of corrosion only occurs in copper based alloys and in the presence of organic acids, moisture, and oxygen.

Luvata has worked in cooperation with a leading 3rd party lab since 2001. This lab has developed the industry standard, accelerated formicary corrosion test. UNIGUARD (4221) alloy was found to be at least 25 times more effective against formicary corrosion than the standard DHP (CA122) alloy.
